Manhole Inspection Summary

Manhole # S37G__017MH

Insp Date: 11/18/08 12:47 PM

Location Address: **e lombard st**

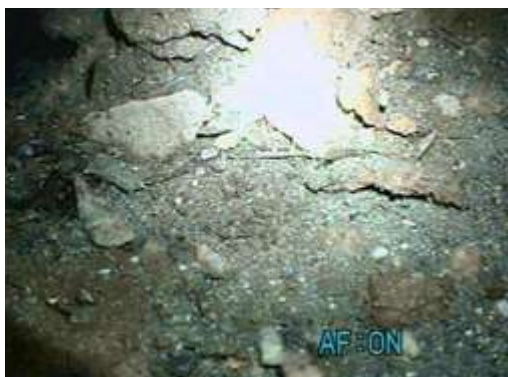
Defect 3

Condition: ☐ Sound ☐ Cracked ☐ Root Intrusion ☐ Deteriorated ☐ Leaks ☒ **Debris**

channel debris

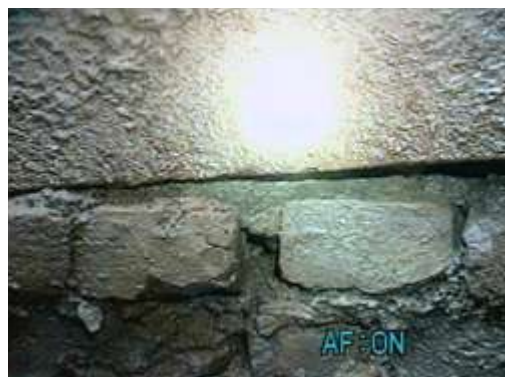
Defect 2

Condition: ☐ Sound ☒ **Cracked** ☐ Root Intrusion ☒ **Loose Brick** ☒ **Deteriorated**

Infiltration: ☐ None ☒ **Joint** ☐ Cracks ☐ Mortar ☐ Roots ☒ **Wall**

Cracks, Loose Bricks and Deterioration in Chimney, Infiltration at Chimney joint

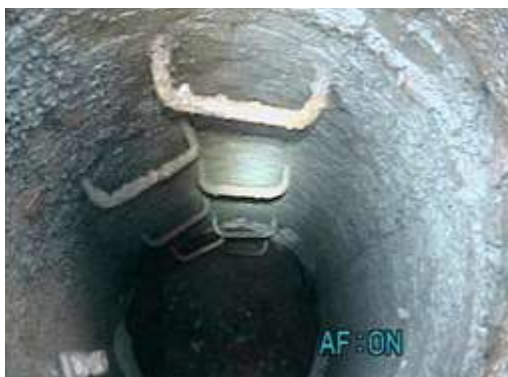
Defect 1

Count: **7** Missing: **0** ☒ **Corroded**

Corroded Steps, Infiltration at Chimney, Corbel and Barrel walls

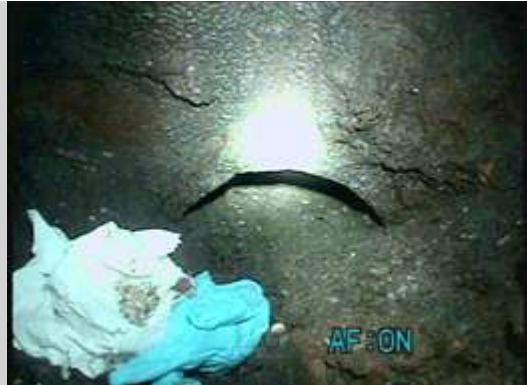
12 O'Clock Outflow

10 in. Circular Gravity Sewer
Pipe Out @ 12 O'Clock

Deposits: ☐ None ☐ Mud ☐ Sludge ☒ **Debris** ☐ Grease

Silt Depth: 7 (in.) Deposits Extent: **Heavy**
